## “Hybridization” Of A Victor RE-57 Console R/P By David Boyle

*This article is primarily a “photo-journalistic-documentary” of this extensive project. My intention in writing this is, perhaps to, motivate some readers to persevere, think beyond their skill level and use some “out-of-the-box approaches” in solving an ever emerging series of repair issues.*

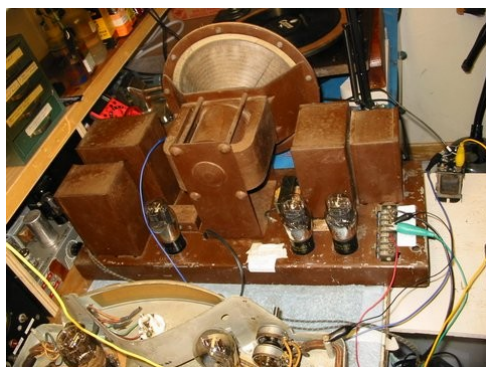
**Photo #1**  
Amp., Power supply & Speaker

Starting first with the power supply and amp. chassis (**Photos 1 & 2**). The required repairs were as expected...these generation chassis seem to have at least 1 or 2 transformers that have failed, I was not disappointed! Repairs were basically filter caps, new push-pull driver transformer, several power resistors and some wiring changes (we will get into this later-on). The chassis provides all required voltages for itself and the radio chassis. An 8 wire cable connects both chassis. The chassis has a mounted 10 inch electro-dynamic speaker, P-P #45 triodes for audio, and # 80 rectifier.

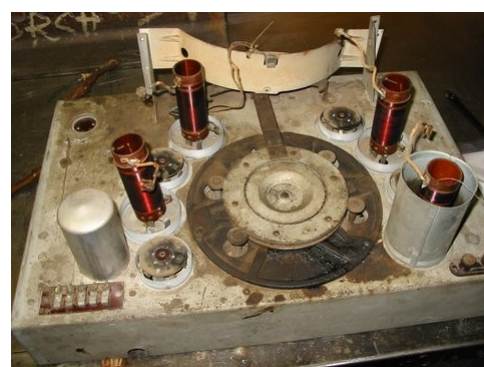
**Photo #3**  
Original RE-57 Radio Chassis

These pictures show the top and underneath of the chassis. Of note: the unique tuning system. The manual tuning lever coming in from the front of the radio is attached to the rotary “turntable”. Horizontal movement of the lever is translated into a back-and-forth circular motion. The four prominent coils (as shown in **Photo 3**)

for each TRF stage are located adjacent to their respective amplifier tube socket.. The underside photo clearly shows the bottom of the tuning “turntable” attached to linkages that reach out to each stage tuning condenser. All tuning condensers are normally enclosed inside an aluminum can shield, now removed for repair purposes.

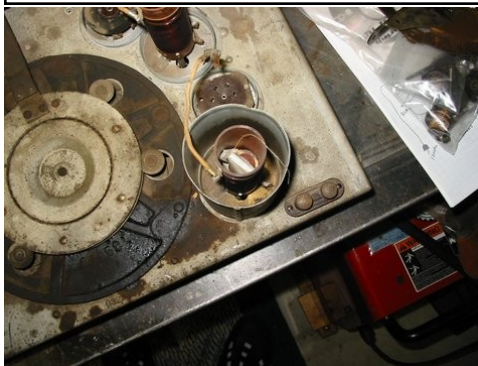
**Photo #5**  
Note: Small coil within Larger coil

Preliminary circuit tests indicated that most circuit components were ok. After powering up and further stage-by-stage testing it was discovered that two small RF coils, each located inside and at the bottom of two of the main RF coils were open. This was an elusive issue because these little coils are not on the schematic! One of these coils is shown in **Photo 5**. The photo shows my feeble attempt at a replacement/repair. Not knowing coil electrical parameters won out...no luck!

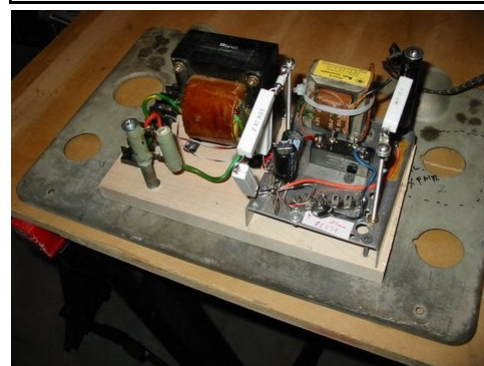
**Photo #6**  
New Power Supply Sub-Chassis

Next step was to design and build a power supply for this radio. The electrical power requirements were quite different than the, now repaired, amplifier/power supply (A/PS) could provide. During the radio chassis final repair and adjustment process it appeared that the optimum B+ voltage for radio performance was only 80 to 85 volts. The filament requirements of the four- # 26 tubes was 1.5 volts ac. The # 27 detector tube requires 2.5 volts ac which was ultimately provided from the A/PS chassis. I built this little power supply on a piece of 1X6 wood using available parts. I “designed-in” ample component margin to ensure relative cool operation and long life. The B+ output is regulated at 82 volts @ 20 ma. and the filament voltage is 1.5 ac @ 4.2 amp. This “sub-chassis” is shown in **Photo 6** during a fit-check to the top plate of the radio chassis where it will be eventually mounted.

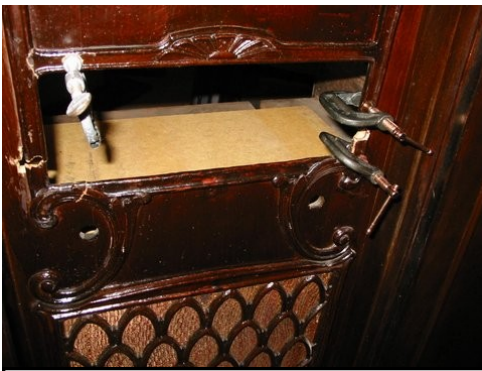
**Photo #13**  
Cabinet Modifications

One cannot help noticing the crappy finish on the console front. It looks like it was varnished with a toothbrush. The owner says that

**Photo 13** "Roughing-in" woodworking modifications including new control shaft holes through the pressed wood decorative molding. They had to be ground out by a die grinder after they started to fall apart using a drill bit.
