Hickok Model 556 Traceometer Restoration

By David Boyle, Club Member

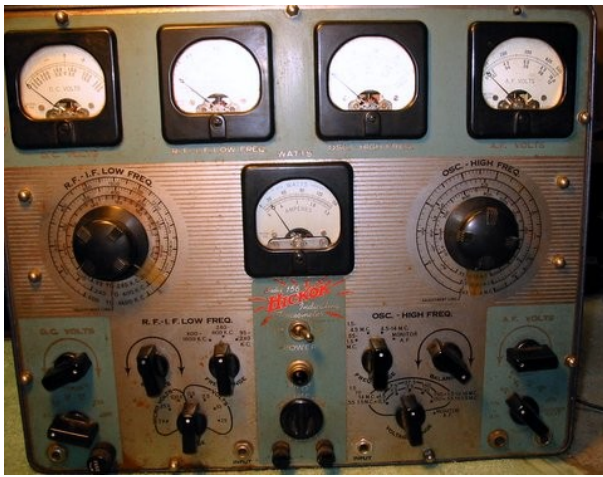
Photo #2

As purchased, the overall visual and cosmetic condition was as expected for an old instrument born in the same year as I! Nothing appeared to be missing internally or externally (**Photo 2 & 3**). The only obvious and somewhat troubling visual issue was corrosion...several types and places. The all important front panel showed lots of grime and scattered rust spots in many areas. **Refer to Photo 2.** There was a severe case of rust and gross corrosion on the bottom of the cabinet interior. This had spread to the inside lower portion of the front panel where all the input jacks are located along with 3 rotary selector switches and attached components (**Photo 4**).resistors and capacitors that all were part of the input impedance and attenuation/voltage dividing circuits. Several other areas on the chassis too.

Some of this severe corrosion originated from the decomposition of three old "D" cell batteries left for many years in a, now destroyed, battery holder/tube. There was no indication of any misuse, overheating, or broken components. In short, this old Traceometer was a *perfect candidate for repair and a partial cosmetic restoration* (considering the rust and corrosion).

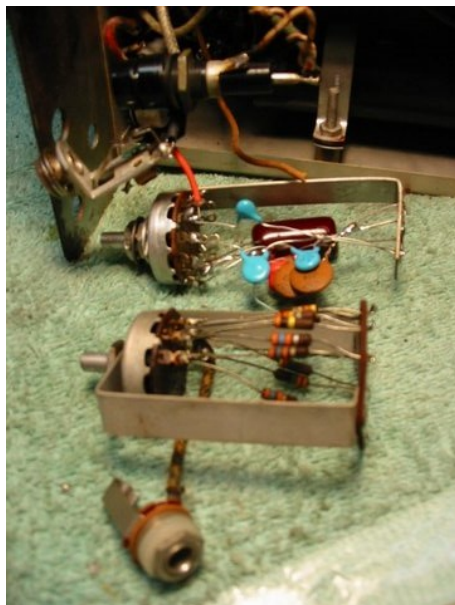
Photo #6

Replaced one rotary selector switch that was corroded beyond repair. Also all the various caps that were attached to this switch. I found a NOS exact duplicate in my parts supply. **Refer to Photo 6**

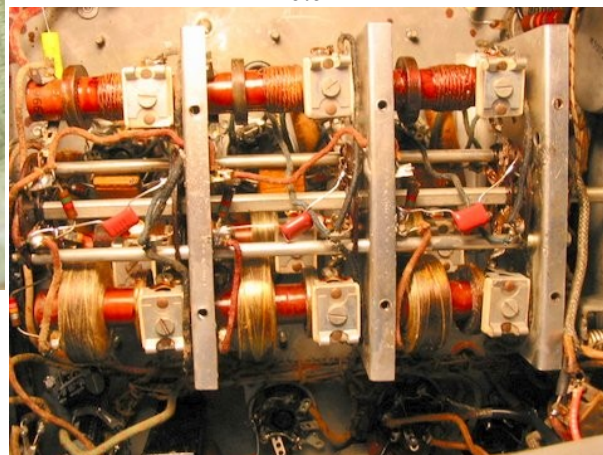
Photo #5

The earlier Traceometer models 155 and my model 156 used a extremely complex RF-IF shielded sub-chassis. **Refer to Photo 5, shown with shield removed.** You may be able to discern where several paper capacitor (caps) were impossible to replace without removing the entire sub-assembly. Forget that! I went ahead and replaced all the remaining Traceometer capacitors, including any resistors significantly out of tolerance.

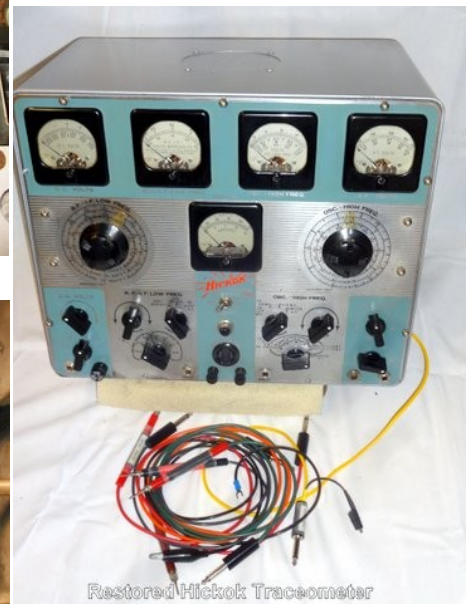
Photo #8

I had to fabricate six special test leads. Each test lead is unique and specific to each test function. Here again “restorer's liberty” was imposed in the color choices for each lead (**Photo 8**). I used the Traceometer schematic and text description as a guide:

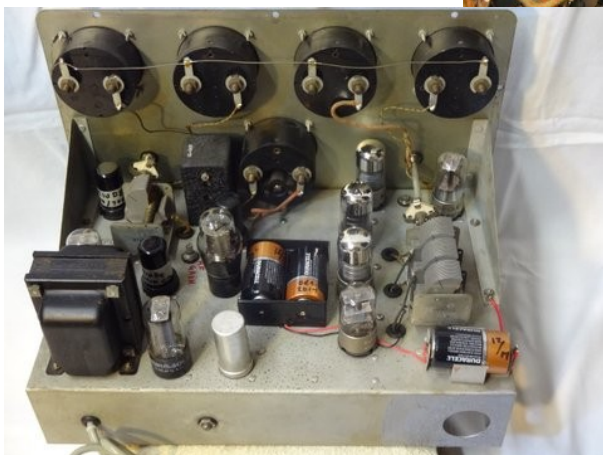
Photo #7

Decided to replace the, now missing, under chassis D cell battery holder by installing commercial clip style holders on top of the chassis (**Photo 7**)...call it “restorer's liberty.” Placed three Duracell batteries with an expiration date of 2023 in them and wired them into the proper circuit. I'll change them out when I reach 83 years old! Remind me, please.
