The Newsletter of
The **Colorado Radio Collectors**
Antique Radio Club

Volume 35, Issue 2

Eliminating Static

in an AA5 radio

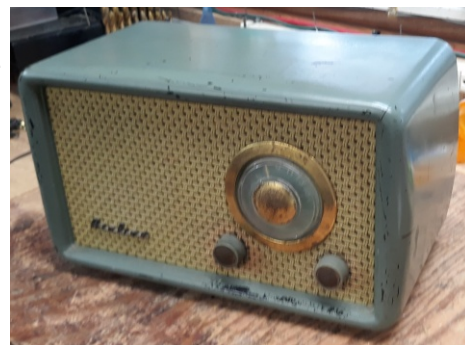
There was no identification on the outside of the radio other than the "Airline" logo on the front. A label on the cabinet back panel indicated it was repaired in Wichita, Kansas sometime in the distant past when phone numbers were shorter like MUrray 5-1215. Neither Karen nor Richard knew the model number, and they had never removed the back panel to look inside. When I asked what was wrong with the radio, they said when they turned it on, it had a LOT of static and no stations could be heard. There was no smoke or sparks! My assessment was that this radio was sold by Montgomery Ward sometime in the 1950's and the static indicated the output tube, output transformer and the speaker were working at that time. With that, we discussed a budget and a time frame for the repairs. I started working on the radio, part-time, 2 days later.

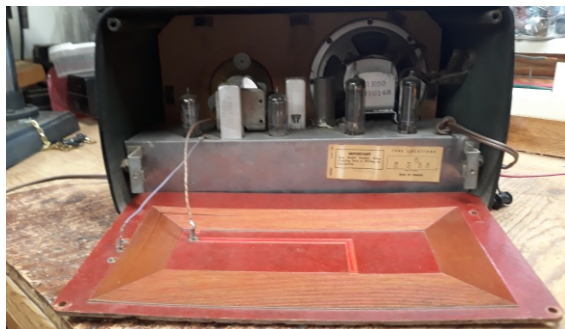
When I removed the cabinet back & loop antenna, a sticker on the chassis included the model # 25GSE-1555A, and a notation it was manufactured in December 1951. The schematic for the radio was then located in Rider's Perpetual Trouble Shooter's Manual Volume 23, on (Montgomery Ward) pages 38-40.

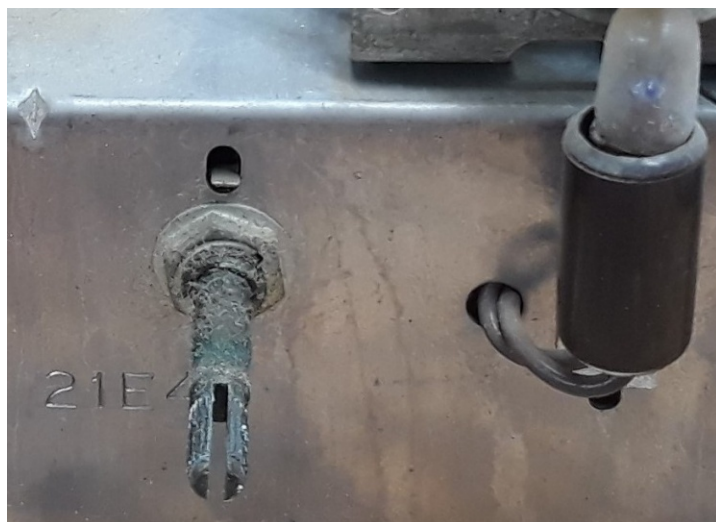
However, I did notice the radio had *possibly* been exposed to fumes from car battery acid. because the brass shaft on the volume control had turned black and there was a coating of a hard white powder-like residue on the outside of the two plastic knobs, and also on the exposed tuning shaft. The printed words and diagrams that were on the cabinet back when it was new, were now only discolored shadows and completely illegible.

Although the Volume Control (VC) had the proper resistance value, the same white powder was possibly on the wiper and resistance surfaces inside the potentiometer (pot). I learned years ago that one dirty connection in the signal path can cause noise and static. So, I removed and opened the VC pot, cleaned what I could with a toothbrush, and sprayed the resistance surfaces with *Caig's ProGold Gx5* contact conditioner. While I had the spray can in hand, I also sprayed the tube pins, the pin socket holes and the tuning condenser contacts. Then I reassembled the unit in the chassis.

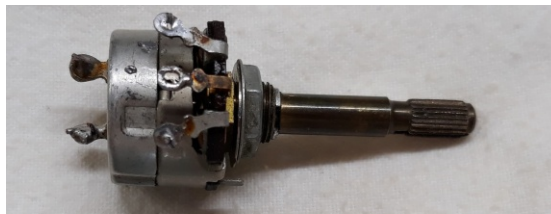
The Original Volume Control

Replacing the original VC pot was not as easy as I thought because it had a long shaft & splines. VC pots with a long shaft & splines are not readily available today, if at all. So, I used a new, short shaft pot + a homemade nylon coupling + a short, splined shaft to get the needed configuration and length.

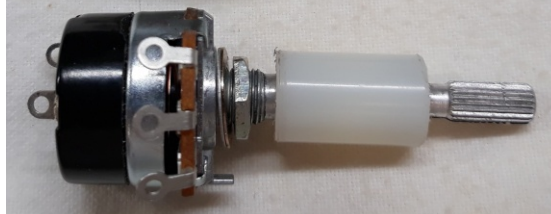
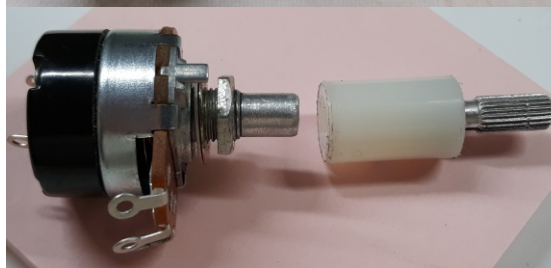
The New Volume Control

The shafts are the same length when the nylon coupling is pushed against the nut after the pot is assembled in the chassis.

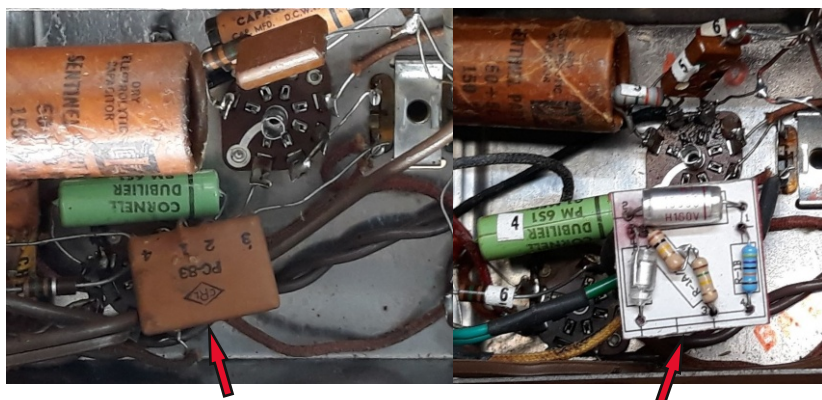
1) **The 'Coupling Plate'** The 'Coupling Plate' is a sealed packet containing 2 resistors and 2 capacitors. It couples the plate of the 12AV6 to the grid of the 50C5. It was difficult to measure the individual values of the capacitors inside the packet. I suspected the 250 pF capacitor was bad.

The original Coupling Plate The new Coupling Plate

I made a new assembly with accessible, discrete components.

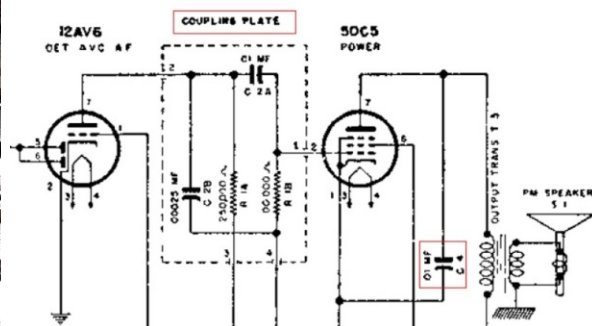
Location of the *Coupling Plate* and C4 on the schematic.

The capacitor in the green plastic case, labeled 4 in the above photo, was also replaced at this time.

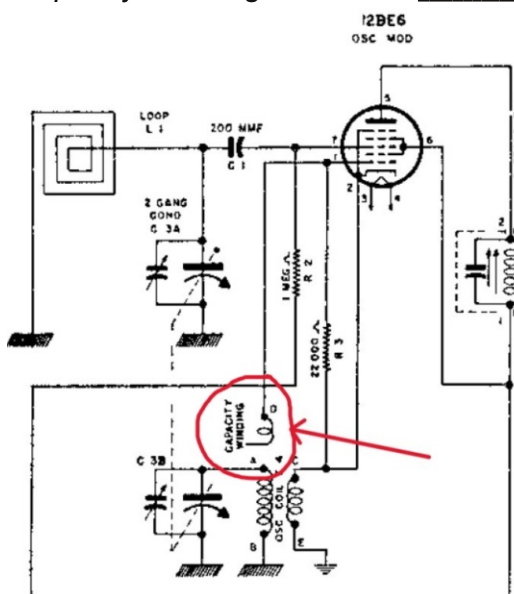
2) The '**Capacity Winding**' wire on the oscillator was not found.

I did find the connection from the 12BE6 grid to tab "D" on the oscillator coil, but not the actual 'Capacity Winding' wire from "D" tab to the coil.

a Location of the *Capacity Winding* on the schematic.

On the schematic, the primary coil of the oscillator coil is inductively coupled to the grid of the 12BE6 tube by what is labeled as the '*Capacity Winding*'. This is merely a turn or two of fine wire wrapped around the main coil of the oscillator.

These few turns of wire, called a '*gimmick*' in some reference books¹ form a small capacitor with the windings of the oscillator coil and in this way the oscillator becomes capacitive-coupled to the grid of the 12BE6.

I replaced the '*Capacity Winding*' wire, wrapping it twice round the primary coil.

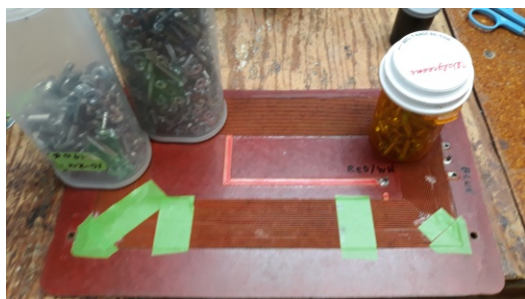
3) **The loop antenna** was separating from the distorted cabinet back. The adhesive deterioration and the back's distortion was likely due to long term exposure to the heat of the 50C5 power tube.

When the radio was handled, the motion of the loose antenna wires changed the loop's capacitance with the chassis, and thereby noticeably affecting the volume and the alignment.

The weighted containers are holding down the loose wires of the loop antenna down while the varnish dried.

The green tape was removed before applying the varnish to the other half.

I re-glued the loop antenna with insulating varnish.

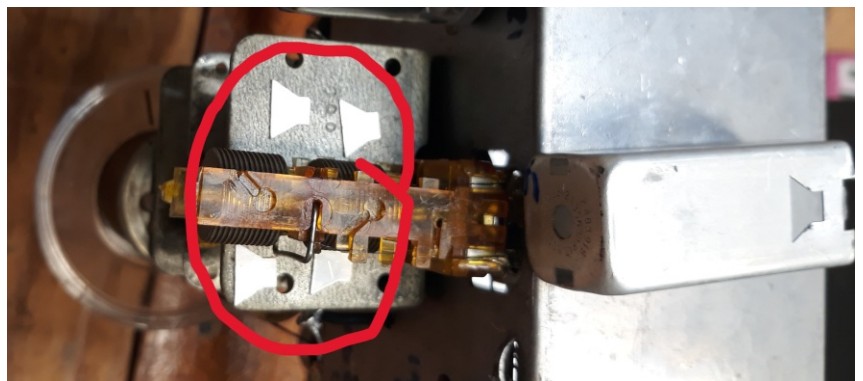
Four aluminum pieces were found inside the can, they are shown below laying on the end of the tuning condenser. They are cutout pieces from the retainer clip holes in the sides of the can.

There are only 2 holes per can, not 4. Therefore, at least 2 pieces came from other units; maybe all of them, depending on how they may have ended up inside the can more than 70 years ago.

The pieces are small enough they fit anywhere around the tuning slugs jamming them up and/or blocking the slots for the alignment tool. The pieces of loose debris were most likely, intermittently, shorting the steel adjustment slugs to the grounded I.F. can. The sharp edges on the debris may have also, intermittently, shorted the internal coil wiring to the grounded I.F. can.

Needless to say the pieces were not put back in!
