Volume 36, Issue 5

A UV199 Vacuum Tube Replacement submitted by CRC member Steve Touzalin

Newsletter for The Colorado Radio Collectors Club, founded in the Fall of 1988

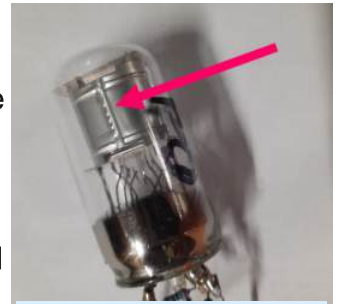
The red arrow shows the seam on the 3Q5GT

The tube pin layouts for the 3Q5GT, and later for the 3LF4, were found in RCA Receiving Tube Manual No. 17 and also on several different online sources. When the 3Q5GT is removed from the base it must be noted where the numbered pin element wires are. On all the 3Q5GT tubes that I had on hand, the piece of metal used to form the plate inside the tube had a seam, which was inline with the key on the base, which was between pins 1 and 8 on the base. This was very helpful once the 3Q5GT glass bulb was removed from the base. I used the information in the sources listed at the end of this article, and added the recommended resistors to the bare 3Q5GT. Without going into any of the details, my first attempt at using a 3Q5GT failed. Using a 4 pin tube base used for 01A's with adapter wires, the new UV199 tested good using the settings

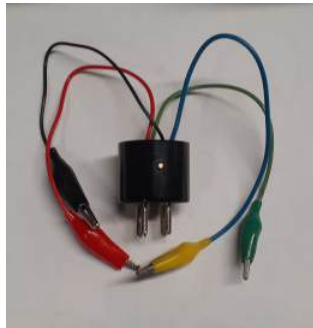
Adapter to test UV199 tube

for a UX199 in my tube tester. It later tested "short" after I had finished assembling it in the UV199 base. I removed the failed 3Q5 bulb from the UV199 base to re-use the base, and pondered my next move.

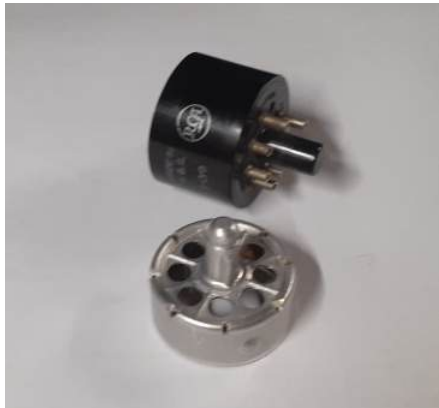
The removed octal base and the notches in the octal shell.

The 3LF4 is also 'silvered' inside the bulb, much like the UV199's I had on hand. My next attempt at a UV199 substitute would be with a 3LF4 octal vacuum tube. Again with safety glasses on, I used a Dremel drill with a cutoff wheel to 'carefully' cut several small shallow notches in the bottom of the metal shell around the octal tube. The tube was then also placed in the small jar of alcohol

using the same procedure as for the 3Q5 tube. The notches allow the alcohol to easily reach inside the metal shell and dissolve the glue holding it to the glass bulb. With the 3LF4 tube, pins 4 and 5 are not used and pin 4 is not present, making it easy to identify the pin numbers once the metal shell is removed. The filament pins, 1 and 8, can be easily verified using a ohm meter.

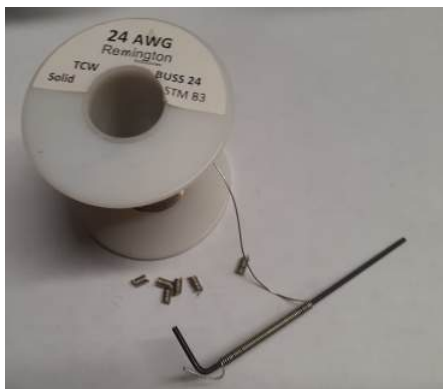
Homemade connectors

The pins on the bare 3LF4 tube were cleaned and small spiral connectors were handmade, using 24 gauge buss wire wound onto a 1/16" Allen wrench as a form, and used to solder the extension wires to the needed pins. Using the information in the sources listed at the end of this article, I soldered a 270 ohm resistor across the filament pins 1 and 8. I also soldered a 220kohm resistor between the screen (pin 3) and the plate (pin 2) as suggested in one of the listed sources. I added an extra 8 ohm resistor, soldered between pin 1, the + filament, and the outgoing extension wire. This should allow the 3LF4 subs to be mixed with real UV199's in the radio, and slightly reduce the gain. Extension wires were soldered to: pin 1

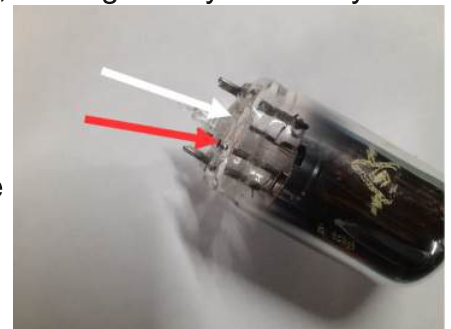
The white arrow above points to missing pin 4, the red arrow points to the nub that is pin 5 on the bare 3LF4.

(+filament with the 8 ohm resistor), pin 2 (plate), pin 6 (grid), and pin 8 (- filament) on the bare 3LF4. Pins 4, 5, and 7 were not used. A small piece of heat shrink was placed over the exposed pin 7 to avoid contact with anything else. I used heat shrink on the other exposed wires. The extension wires were attached to the correct base pins in the salvaged UV199 base using a UV199 tube pin layout as a guide . I double checked the wire placements several times as I noticed that the tube pin layout for the UV199 found in The Cunningham Radio Tubes Manual, C-10, shows the Top View of the tube sockets while the tube pin layout in the RC-12 manual displayed the Bottom View of the tube sockets. Clear Gorilla Glue was used to attach the modified glass 3LF4 to the UV199 base, this was the glue that I had on hand, any similar glue or a hot glue gun would work. Next I soldered the protruding wires to the end of the tube base pins. The tube substitute tested at the maximum reading of the meter scale on my tube tester. The new tube may have too much gain, we'll see. I proceeded to make four more of the replacement tubes. Simichrome Metal Polish was used on the glass bulb of the glued 3LF4's to remove all the markings and tube numbers to mask the original identity of the counterfeit UV199's.

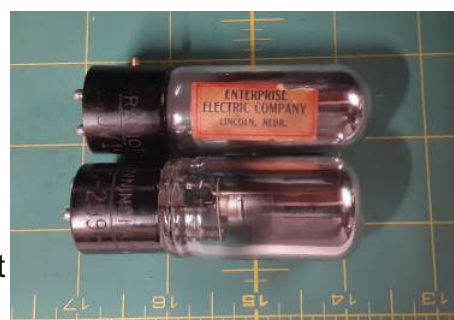
The top tube is a real UV199 tube, complete with a radio shop sticker from a shop in Lincoln, Nebraska. The bottom tube is a re-based 3LF4.

While in the process of making the remaining four tube substitutes, I was able to purchase four UV199 tubes with good filaments and emission at a very decent price. I now have 5 real UV199 tubes and 5 counterfeit UV199 tubes to try in my radio. After adding a new On/Off switch, and repairing one of the control rheostats on my set, I was now ready to at least see if the radio and my tubes worked. An original UV199 (on top) and a counterfeit UV199 (on the bottom) are pictured to the right.

I was very pleased with the results of the counterfeit UV199 tubes. They look good in the radio and would probably fool a lot of people to the fact they are not actually real UV199 tubes. They performed as they should have with the rheostats already in the radio, which some have said is often a problem with substitute tubes. And this radio will now work when I am completely finished with it. I can not guarantee that these re-based tubes will work properly in other radios, but I would definitely be willing to try them in other radios. The 3Q5GT vacuum tubes should work exactly the same as 3LF4's if they were used, and would probably be easier to assemble now using Blu Tack as an aid. I am unsure if the added 8 ohm resistor that I used was necessary, but based on the results that I experienced I would include the added 8 ohm resistor in any future 199 tube replacements. This procedure should also work for UX199 tubes if the proper base and tube pin-out is used. I hope this helps and encourages others to try this process for 199 tube replacements or adapters.

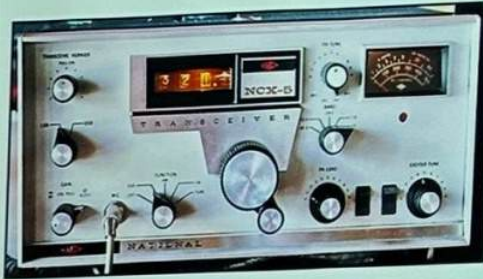
National Radio Company

- 1914: National Toy Company
- 1923: Added appliance manufacturing; changed to National Company Inc
- 1925: Manufactured a BCB receiver designed by 2 Harvard students
- 1930s: Started making ham radio equipment; 200 employees
- 1939-1945: Made radios for US and allies; 2500 employees
- 1947-1958: Models NC-173, -183 and -183D
- 1964-1965: NCX-5 transceiver with mechanical digital dial for \$695.00
 - (\$7K in today's dollars)
